**Flood Control Project Maintenance
Levee Inspections
2008 Channel Summary Report
Overall Unit and Item Ratings**

Adin Community Service District

Flood Control Project Maintenance
Inspection Report - Channel 2008

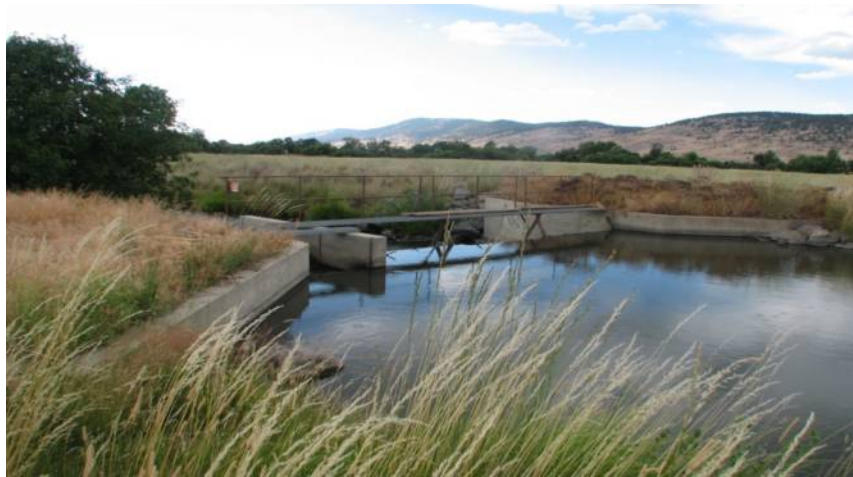
Report Line	1
Location	
Category	Structures & Concrete Lined Channels
Item	Concrete Foundations
Dam with fish ladder and metal walkway, constructed Oct. 1999 by the Dept. of Fish & Game

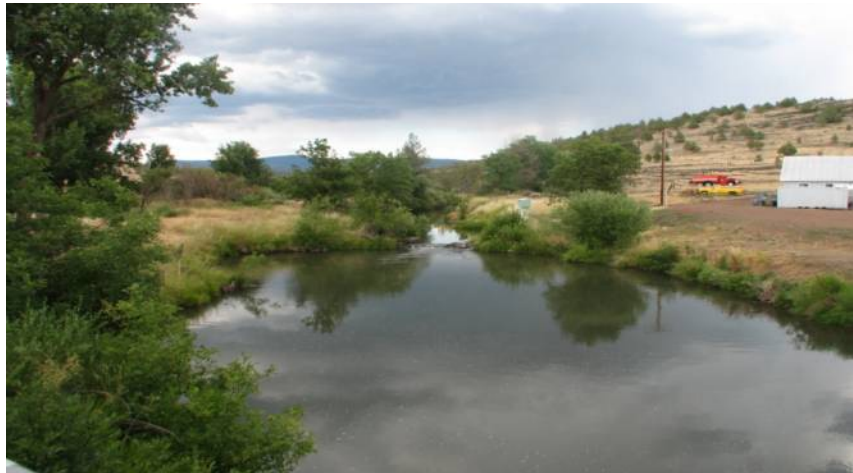
Report Line	2
Location	
Category	Rivers, Channels & Designated Floodways
Item	Vegetation & Obstructions
From Main Street (Highway 299) towards the gauging station

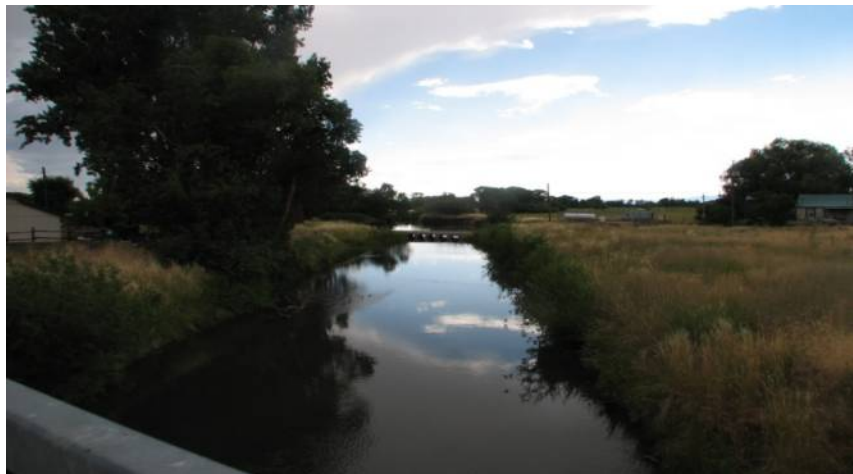
Report Line	2
Location	
Category	Rivers, Channels & Designated Floodways
Item	Vegetation & Obstructions
From Main Street (Hwy. 299) at the Ash St. low water crossing

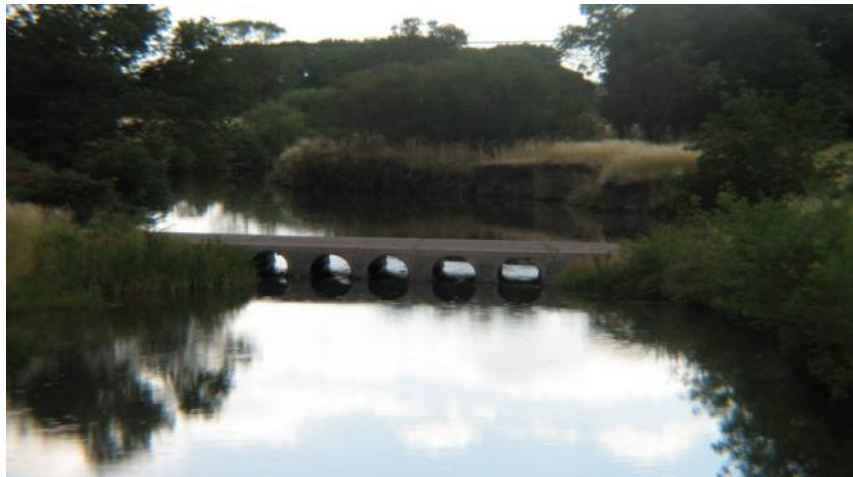
Report Line	4
Location	
Category	Rivers, Channels & Designated Floodways
Item	Erosion
From Ash Street moderate tree growth and bank erosion

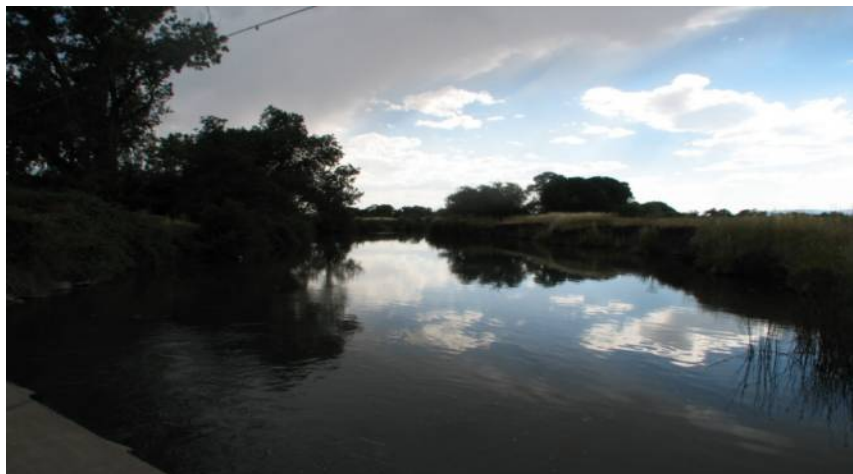
Report Line	5
Location	
Category	Rivers, Channels & Designated Floodways
Item	Erosion
Downstream at a sharp left bend moderate erosion on both banks

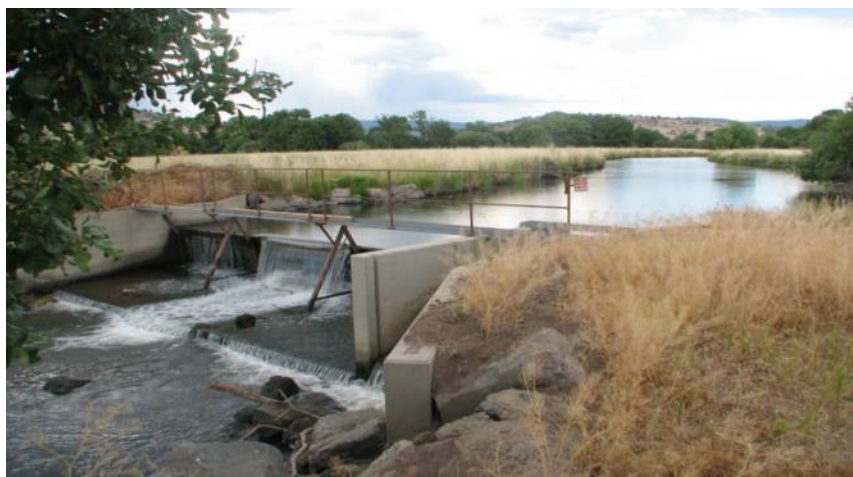
Report Line	6
Location	
Category	Rivers, Channels & Designated Floodways
Item	Concrete Foundations
Upstream from the downstream limit

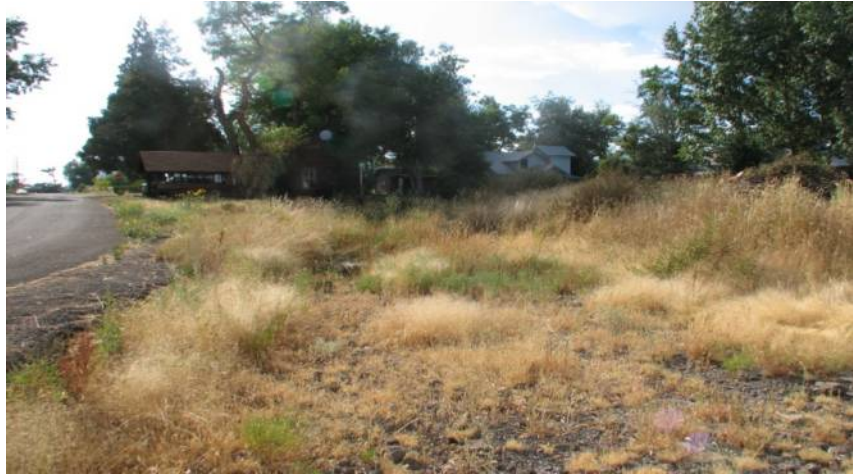
Report Line	1
Location	
Category	Rivers, Channels & Designated Floodways
Item	Vegetation & Obstructions
Downstream at Cedar Street moderate growth in channel

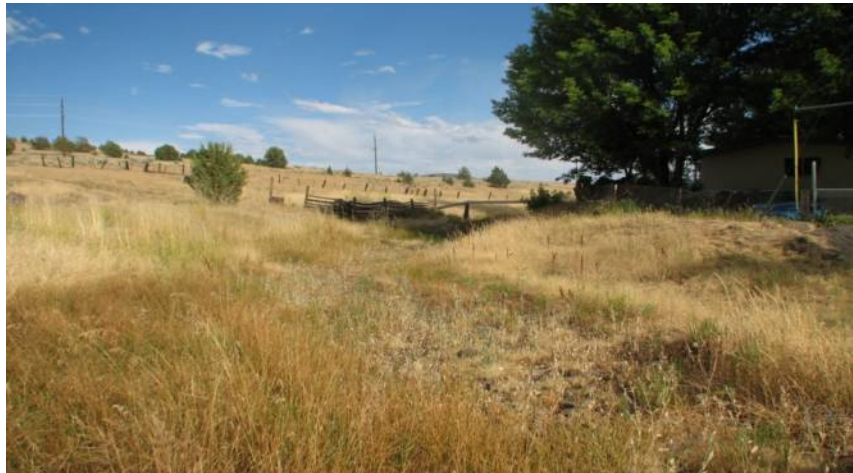
Report Line	2
Location	
Category	Rivers, Channels & Designated Floodways
Item	Vegetation & Obstructions
Upstream at Cedar Street minimal growth in channel

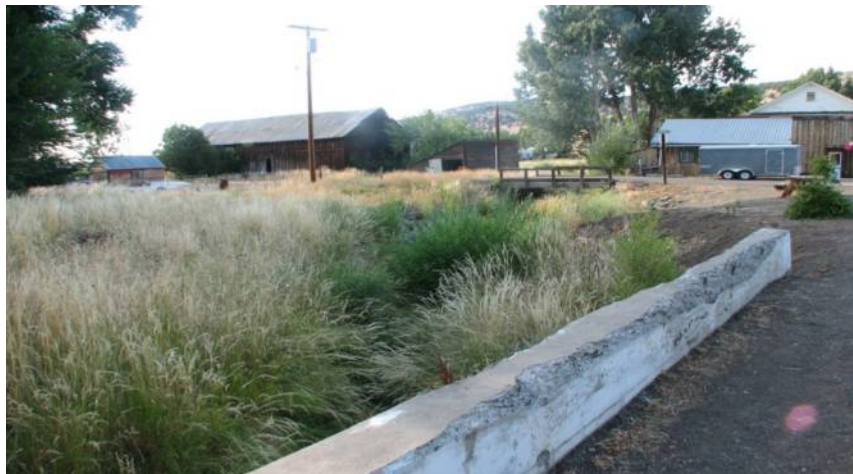
Report Line	3
Location	
Category	Rivers, Channels & Designated Floodways
Item	Vegetation & Obstructions
Downstream from Main Street (Hwy 299) moderate growth in channel

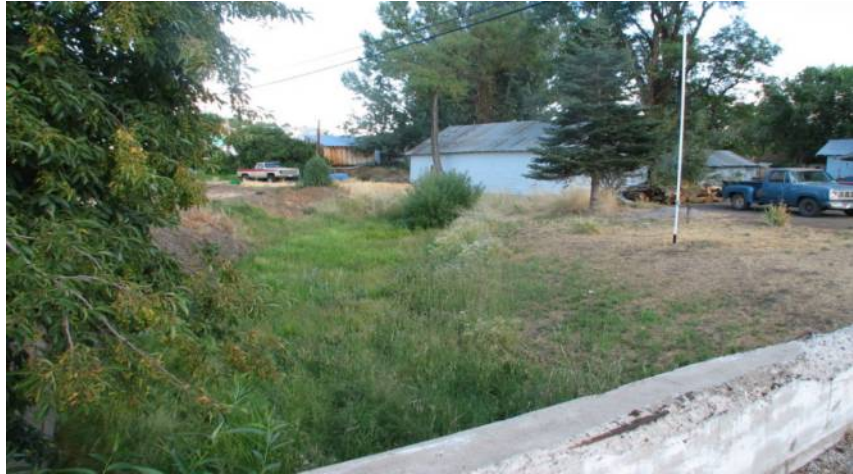
Report Line	4
Location	
Category	Rivers, Channels & Designated Floodways
Item	Vegetation & Obstructions

Upstream from Main street (Hwy 299) minimal growth in channel
